Inspection Report

Minerals Regulatory Program

Mine Name: Soma Quarry	Permit Number: S0230065
Operator Name: Nephi Sandstone Corp.	Inspection Date: August 31, 2010
Inspector(s): Wayne H. Western, Ivan Djambov legislature auditor, Jill Marriott accounting department	Time: 9:20 -9:40 AM
Other Participants: None	Mine Status: inactive

The purpose of the inspection was to determine if the overhang had been removed.

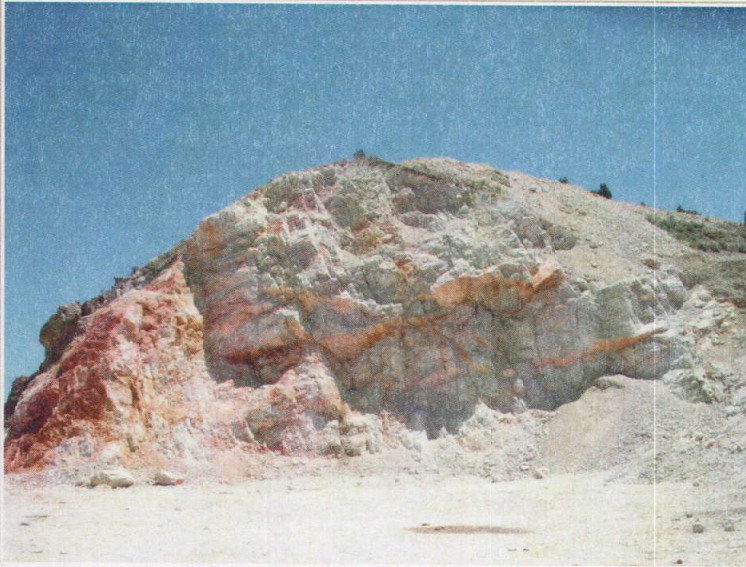
July 14, 2009

On July 14, 2009, the Division conducted a routine inspection and Division staff noticed that there were overhangs on the highwalls. The Division notified the Operator of the overhangs on the highwall. On November 5, 2009, the Division inspected the site. The Operator had removed some but not all of the overhangs. On April 27, 2010, the Division conducted a follow up inspection and noticed that there are still overhangs on the highwall. On August 31, 2010, the Division visited the site and determined that the overhangs were still present although the Permittee had placed some backfill against the highwall. The Division will proceed by writing a cessation order.

The Operator failed to eliminate all of the overhangs on the highwall. The Division will issue a cessation order that will require the Operator to eliminate all of the highwalls
